## Written Testimony on SB 275

Secretary Jeff Zmuda  
Kansas Department of Corrections

Kansas Department of Corrections  
Executive Summary

June 2022

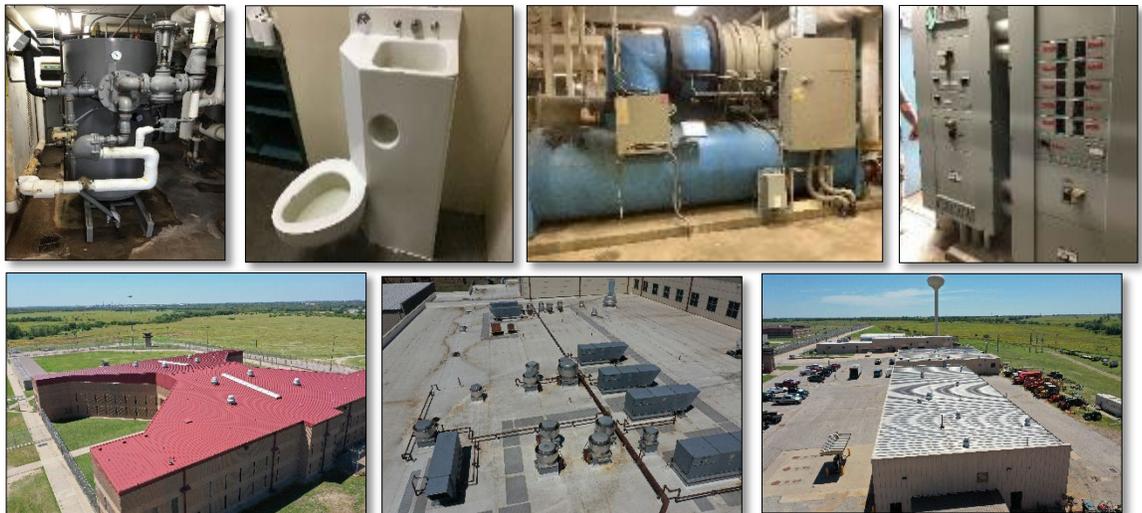
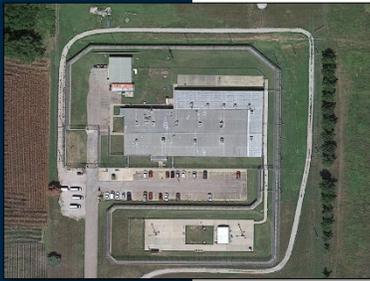
### PHOTOS:

- Original construction date of 1991. Many of the support systems have not been upgraded since construction and need lifecycle replacements.
- The Mechanical systems are original to construction and are past their useful life. These aged systems need to be replaced.

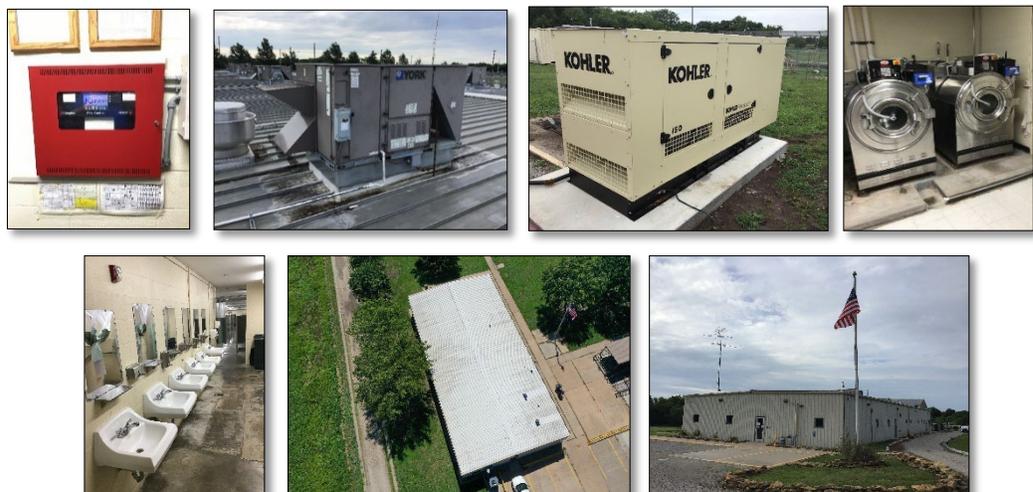
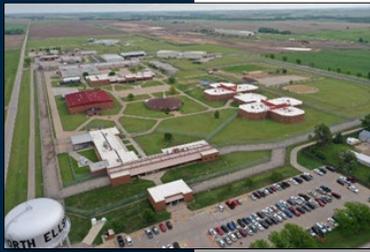
### PHOTOS:

- Fire systems are dated.
- Mechanical, Electrical, and Plumbing systems showed wear due to the age of the buildings.

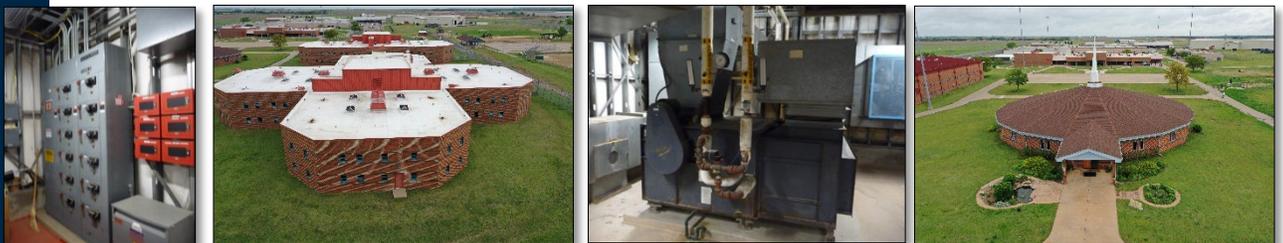
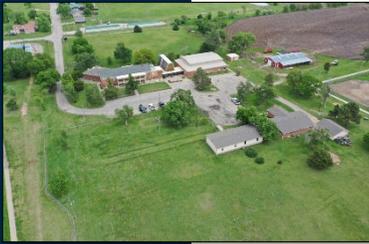
### PHOTOS:

- The piping in Medium Housing next to pod 109 appears to be in a deteriorating state and to be original to construction.
- Mechanical, Electrical and Plumbing systems wear due to the age of the older buildings and heavy use and abuse that occurs in detention facilities.

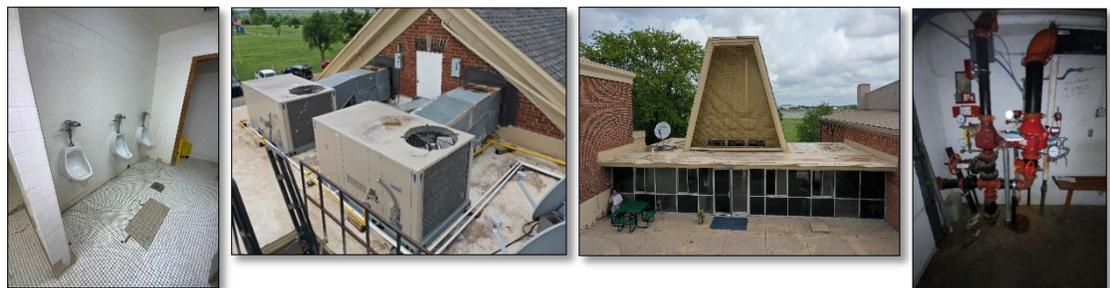
### PHOTOS:

- Mechanical, Electrical and Plumbing systems wear due to the age of the older buildings and heavy use and abuse that occurs in detention facilities.

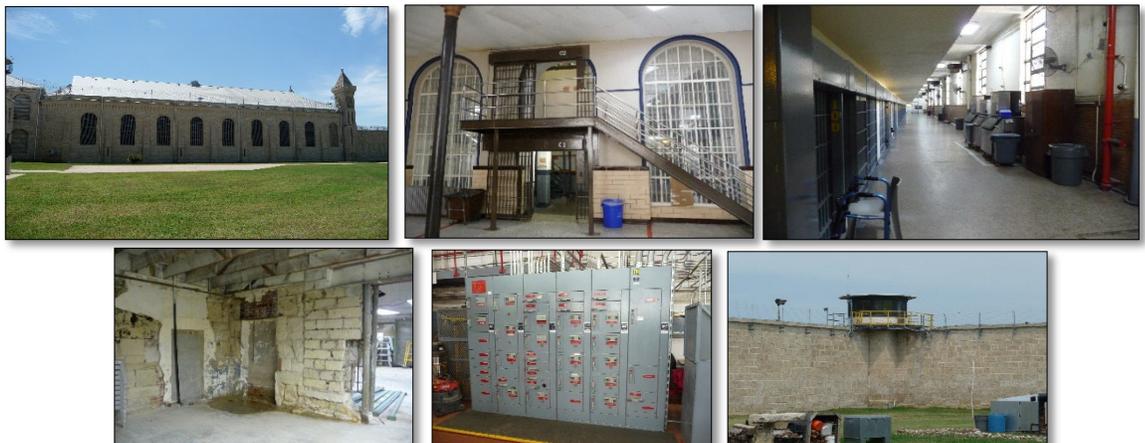
### PHOTOS:

- Built in the 1890's, it is a 130-year-old facility.
- Cell houses are old and small and do not meet current standards.
- There is no fire protection in the cell houses and not up to date with current standards.

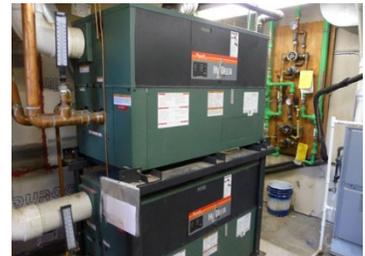
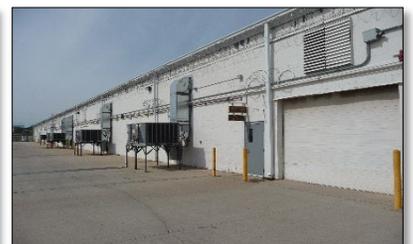
### PHOTOS:

- Admin building is getting a new roof, service building has roof issues and is undersized.
- Some dorms are not sprinkled and have settling issues.

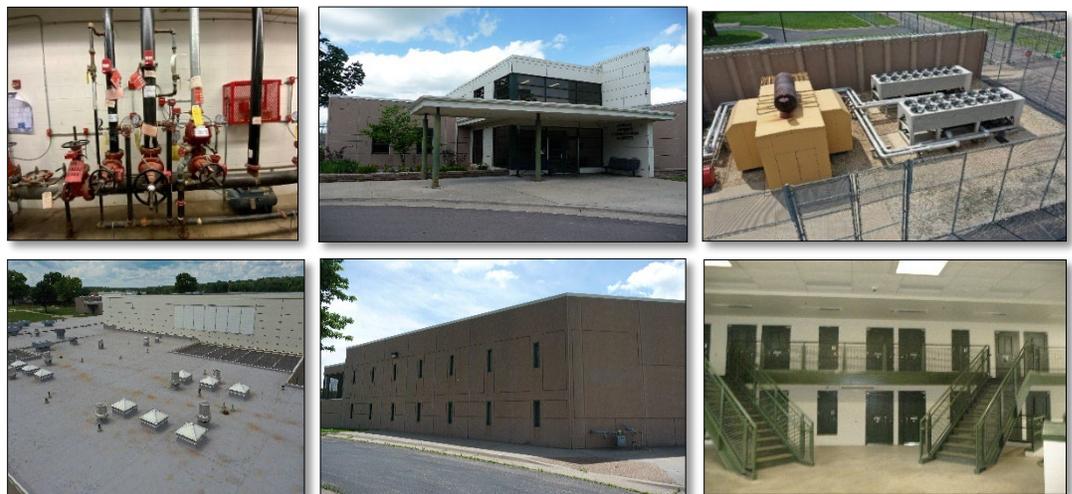
### PHOTOS:

- Two McQuay 250 Ton chillers are nearing the end of useful life.
- Recommendation would be to add enough generator power to have facility 100% supported by emergency power due to the critical nature of the facility.
- Fire protection was original to construction. A lifecycle replacement of fire alarm panels and associated devices is recommended before unplanned failures occur.

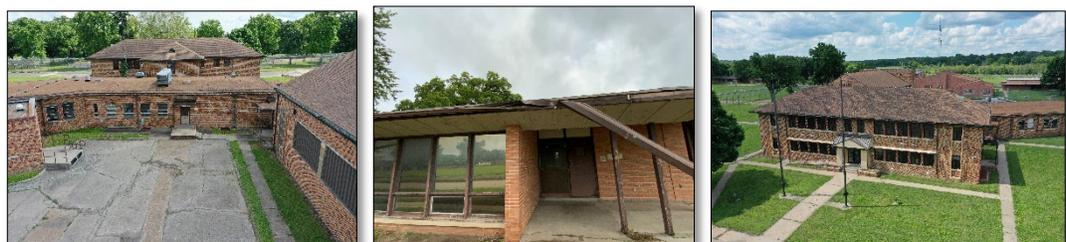
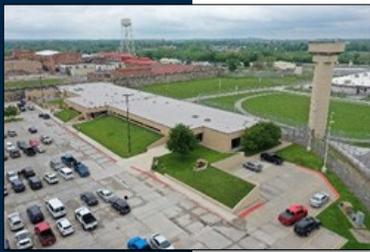
### PHOTOS:

- Some of the buildings within the facility remain as originally constructed and are not currently in use or are used for surplus storage at the site.
- Site utilities were aged and currently not in service in parts of the facility.
- Mechanical, Electrical and Plumbing systems wear due to the age of the older buildings and heavy use and abuse that occurs in detention facilities.

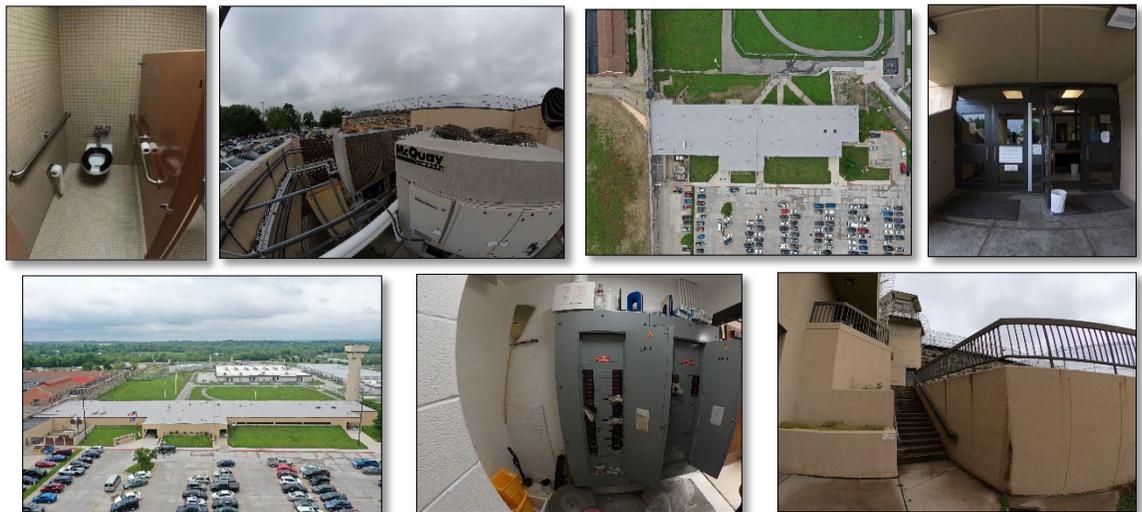
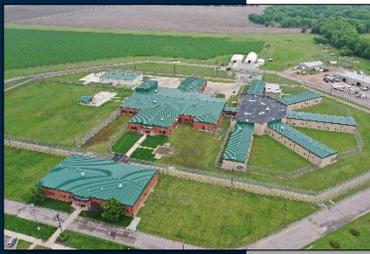
### PHOTOS:

- The plumbing throughout the site is mostly original to construction and is a combination of PVC, galvanized steel, and copper piping.
- The aged-out HVAC systems should be considered for replacement soon.

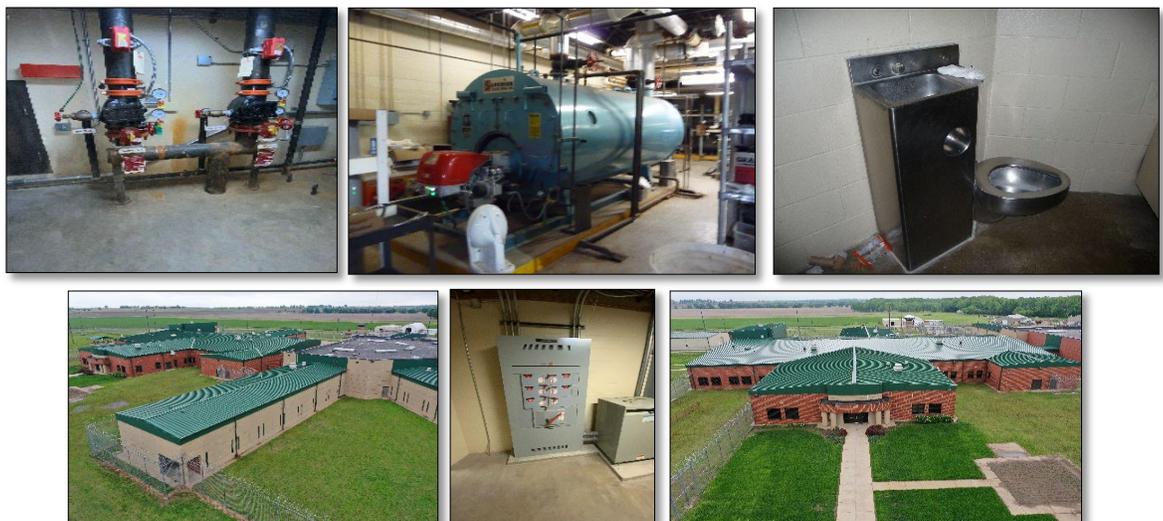
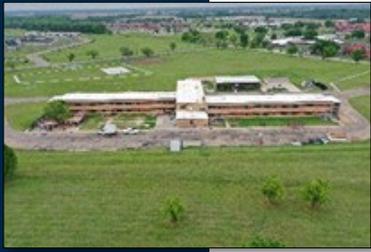
### PHOTOS:

- Mechanical, Electrical and Plumbing systems are the same age as building, except for a few flush valves. Waste water grinder has been an issue.

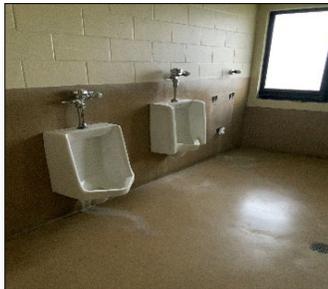
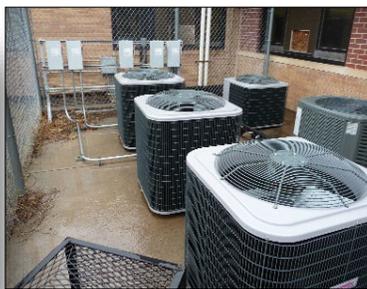
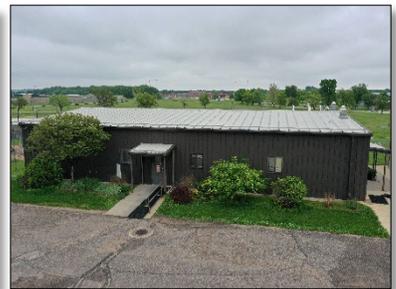
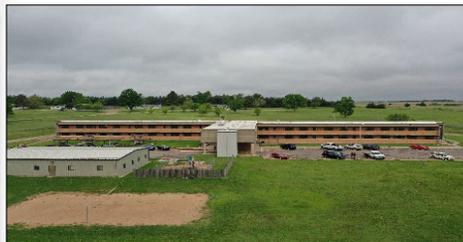
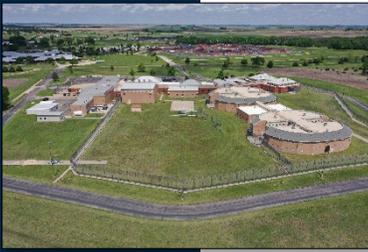
### PHOTOS:

- Mechanical, Electrical and Plumbing systems wear due to the age of the older buildings and heavy use and abuse that occurs in detention facilities.

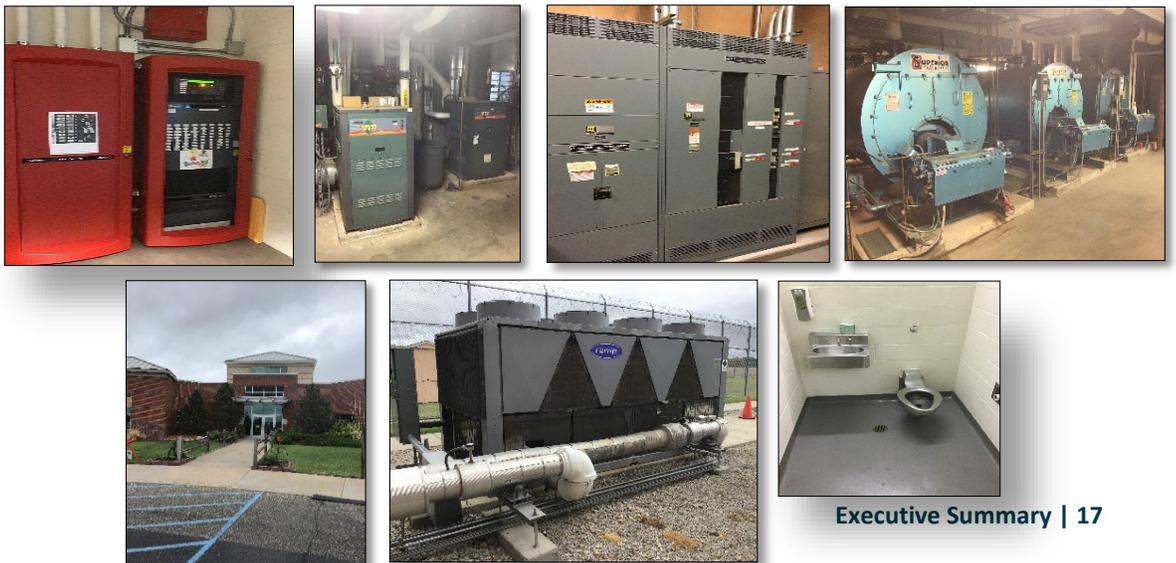
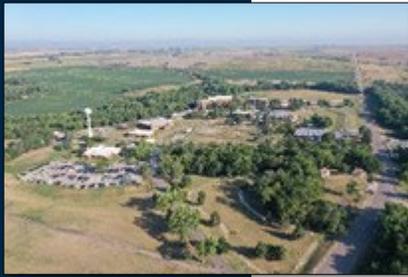
### PHOTOS:

- Mechanical, Electrical and Plumbing systems wear original to construction in 2001 and were approaching or at the end of their lifecycle. Aged out MEP equipment needs to be replaced.

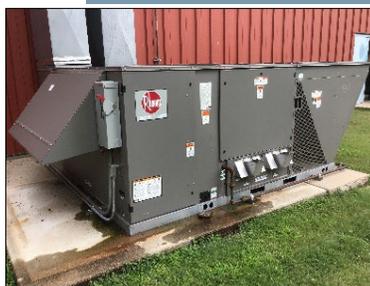
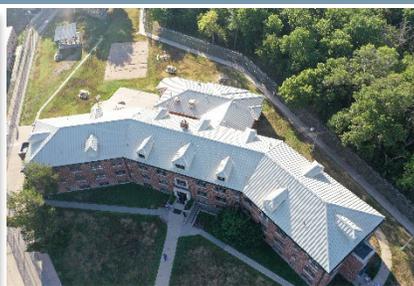
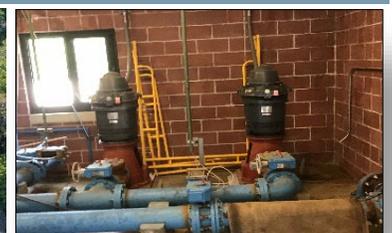
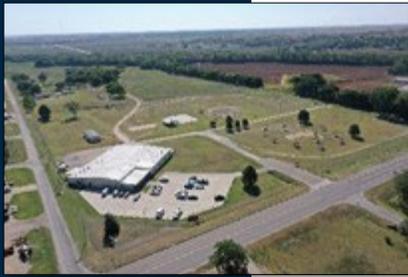
### PHOTOS:

- Site Utilities are from 1920's era. The sanitary sewer mains, domestic water mains and electrical service require upgrades.
- Sanitary System utilizes a lagoon system. Existing lagoon needs to be enlarged to handle facility sanitary sewer needs.
- KDOC is monitoring issues with ground water contamination and well water filtration.

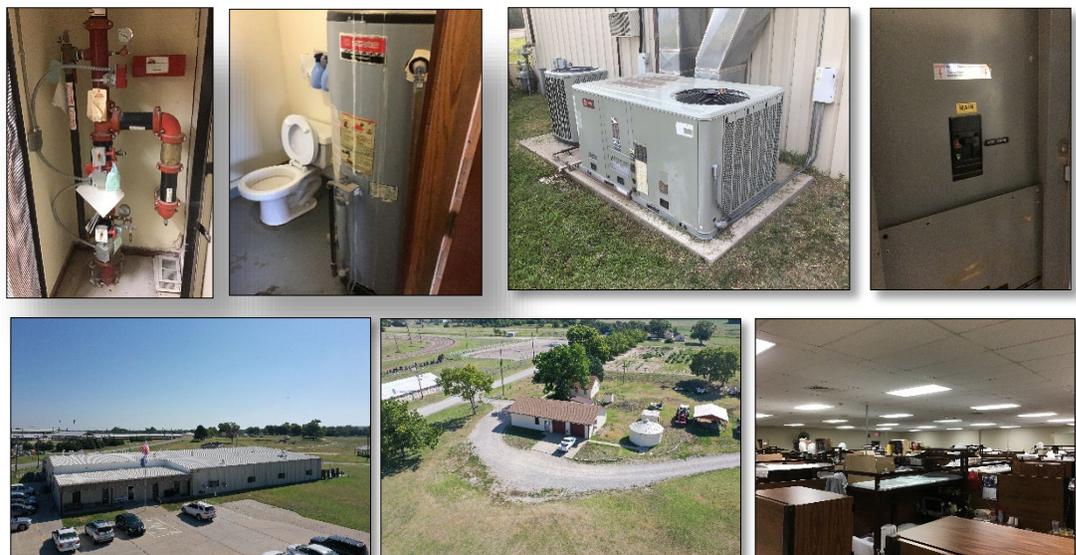
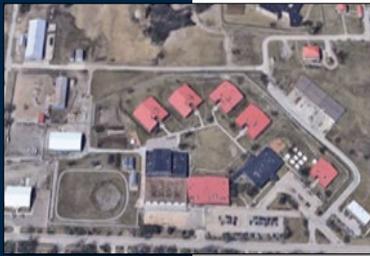
### PHOTOS:

- Mechanical, Electrical and Plumbing systems wear due to the heavy use and abuse that occurs in detention facilities.

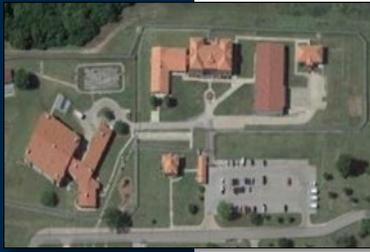
### PHOTOS:

- The facility was built in 1974 and the site utilities are original to construction. Sanitary sewer mains, domestic water mains and electrical service need to be upgraded.
- Mechanical, Electrical and Plumbing systems wear due to the age of the older buildings and the heavy use and abuse that occurs in detention facilities.

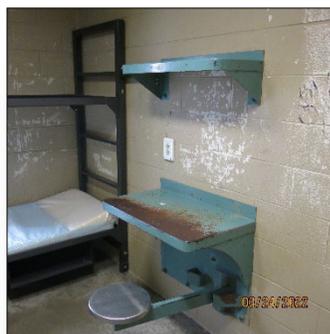
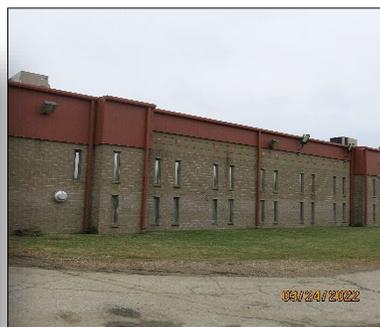
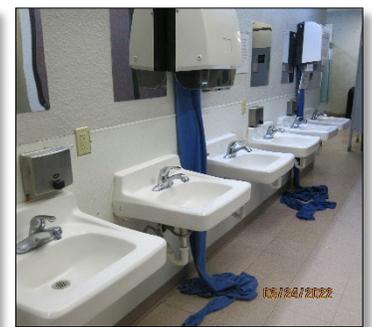
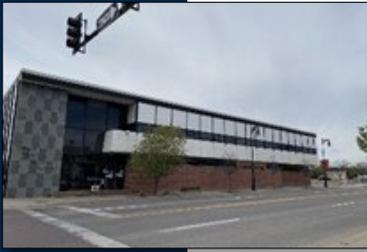
#### PHOTOS:

- The “J” Dorm was used as a college dorm in the 1920’s -1940’s and later was converted to a correctional facility.
- The “I” Cellhouse was built in 1994.
- “J” Dorm has over \$5.5MM in deferred maintenance and should be considered for replacement.

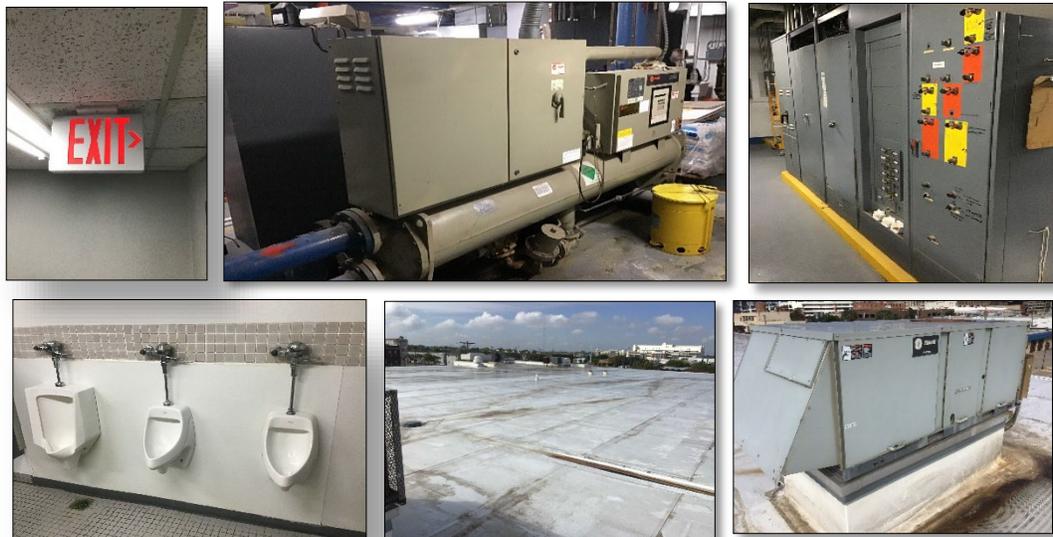
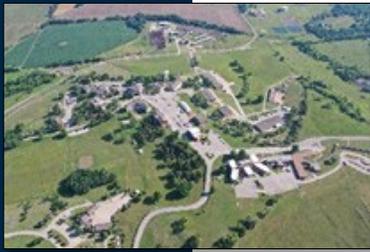
#### PHOTOS:

- Approximately at 60% capacity at time of inspection.
- Mechanical, Electrical and Plumbing systems wear due to the age of the older buildings and heavy use and abuse that occurs in detention facilities.
- VCT flooring is about 85% of the floor finish and should be replaced.

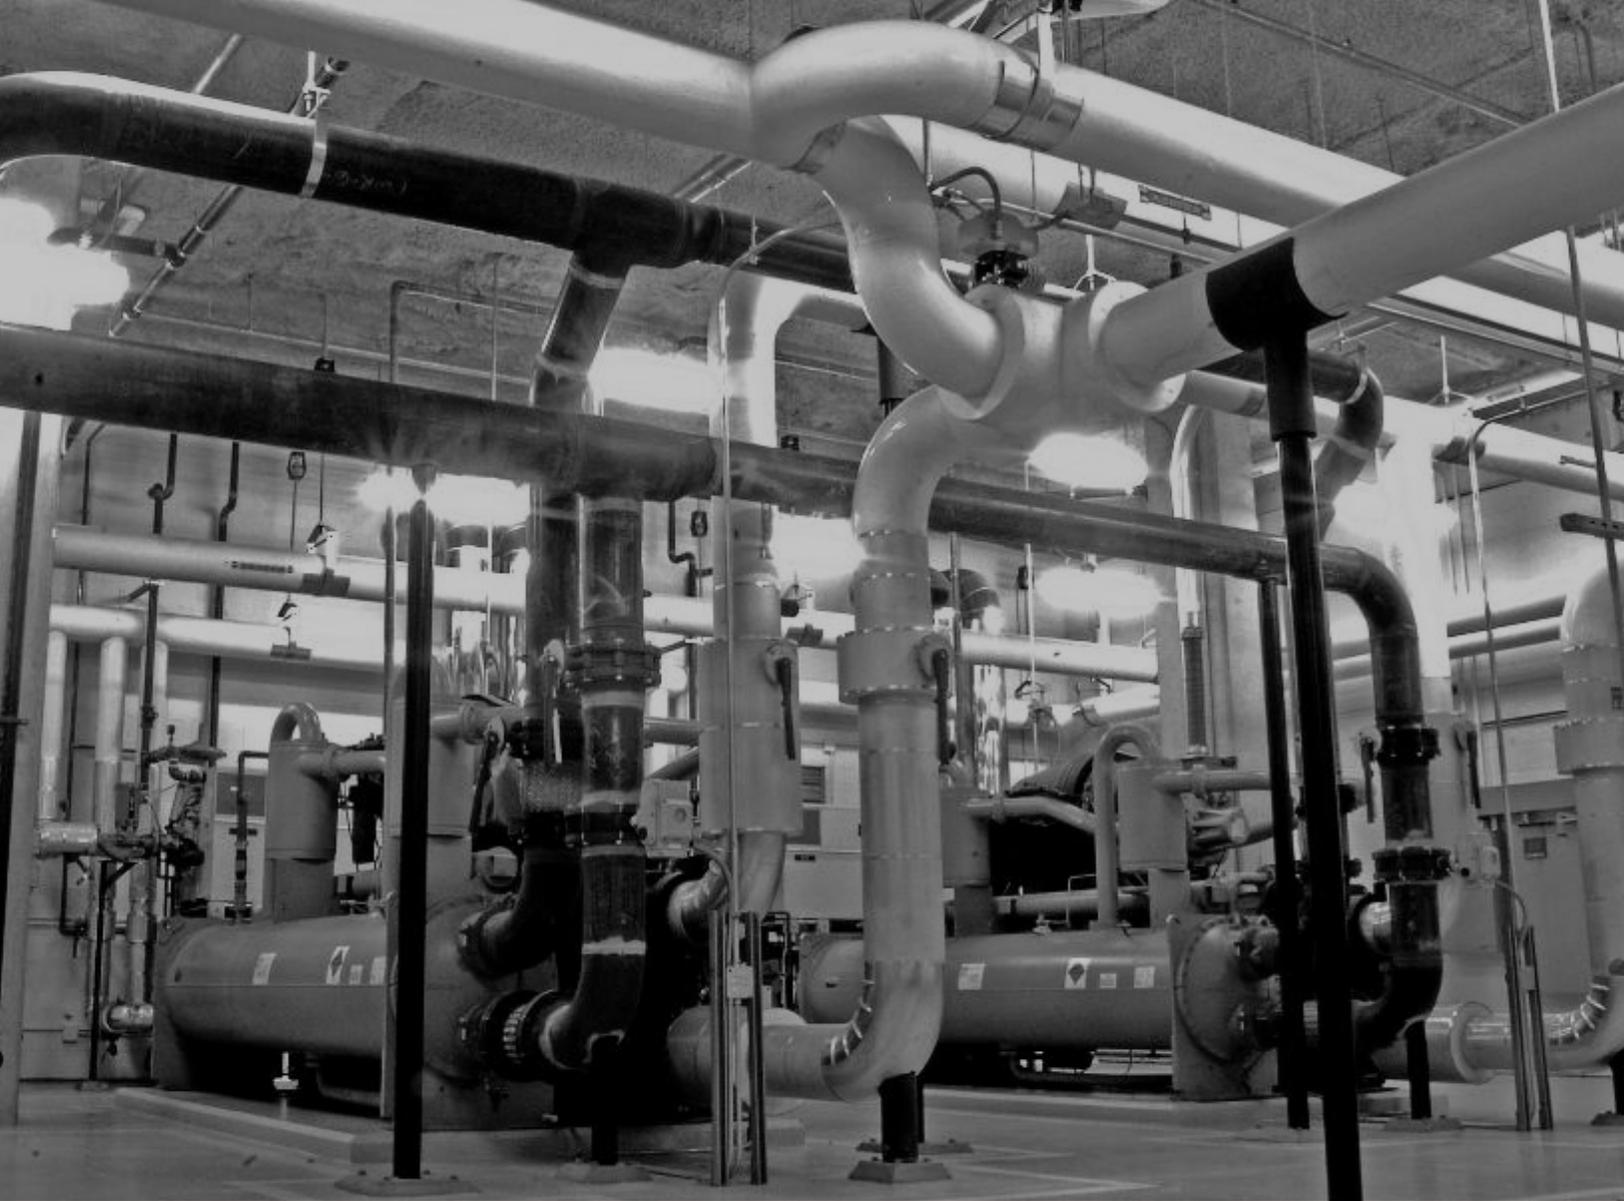
#### PHOTOS:

- Facility is on the site of the old state hospital. Many of the site utilities are from early 1900's. The sanitary sewer mains and domestic water mains require upgrades.
- Water Tower is aged and needs to be replaced.
- Windows are aged and need to be replaced.
